Section 7 Results of Fieldwork

7.1 Results of Pedestrian Inspection

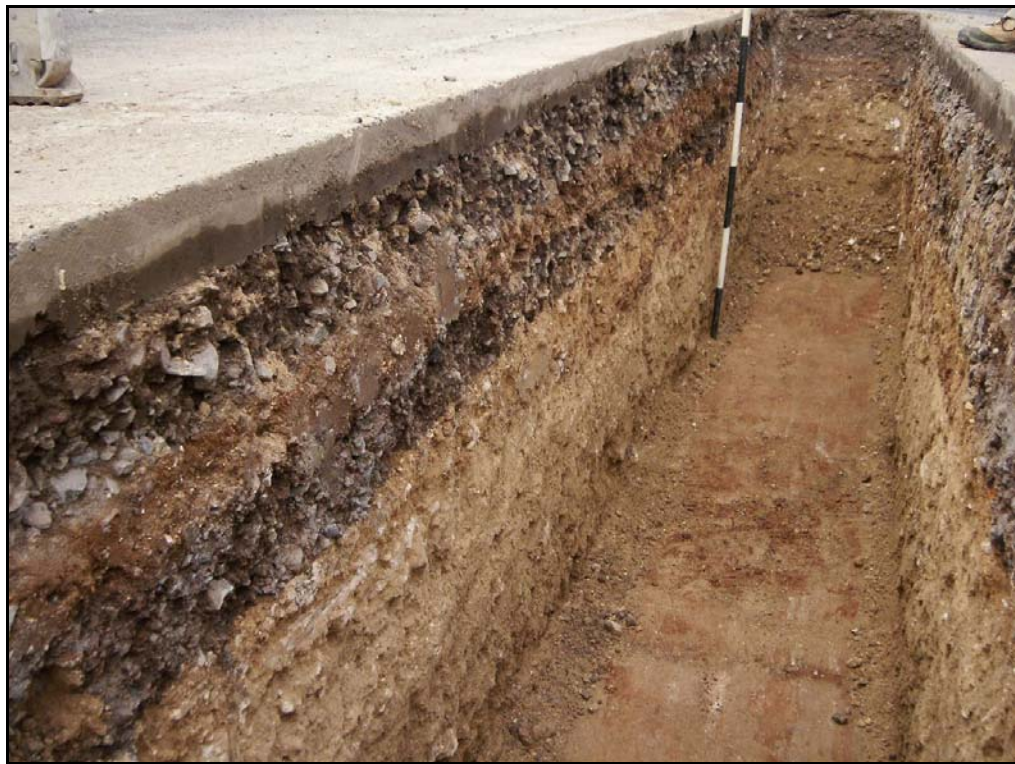
Stratigraphic Summary: The stratigraphy consisted of fill strata overlying a concrete slab (Figure 180 and Figure 181). Observed strata were asphalt (Stratum Ia), basalt base course (Stratum Ib), and gravelly silty sand fill (Stratum Ic) overlying a buried concrete slab (Stratum II). The stratigraphy of T-024 conformed to the USDA soil survey designation of Fill land (FL).

Feature Discussion: One feature, designated as SIHP # 50-80-13-7421 Feature 1, consists of a buried concrete slab (Stratum II) encountered at 1.08 mbs and extending beyond the boundaries of the excavation area. The thickness was estimated to be greater than 10 cm. Feature 1 was

Figure 180. Photograph of Airport Section 3, T-024, general view of profile, view to west

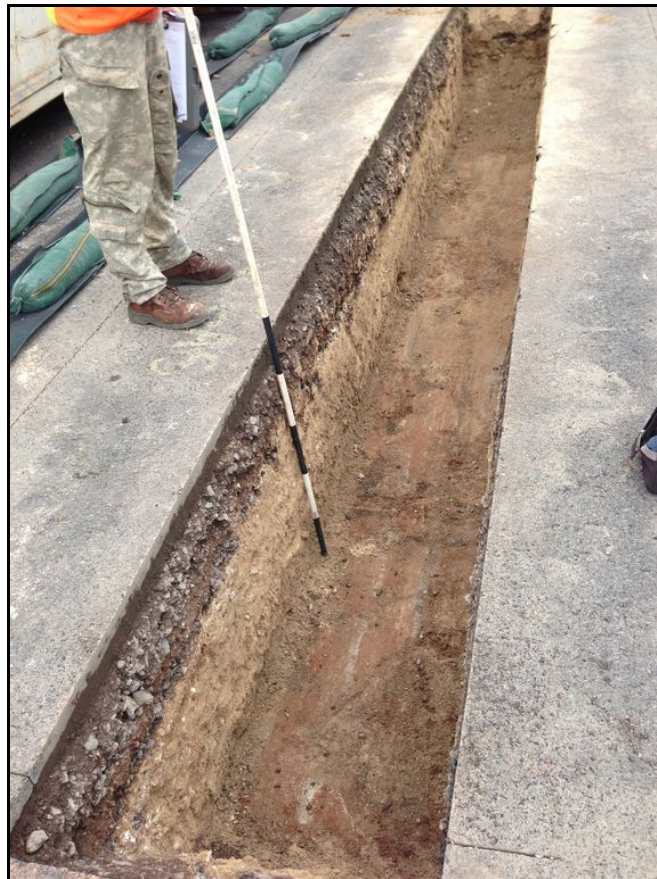
Feature Discussion: One feature, designated as SIHP # 50-80-13-7421 Feature 1, consists of a buried concrete slab (Stratum II) encountered at 0.90 mbs and extending beyond the boundaries of the excavation area. The thickness was estimated to be greater than 10 cm. Feature 1 was

Figure 183. Photograph of Airport Section 3, T-025, general view of profile, view to northeast

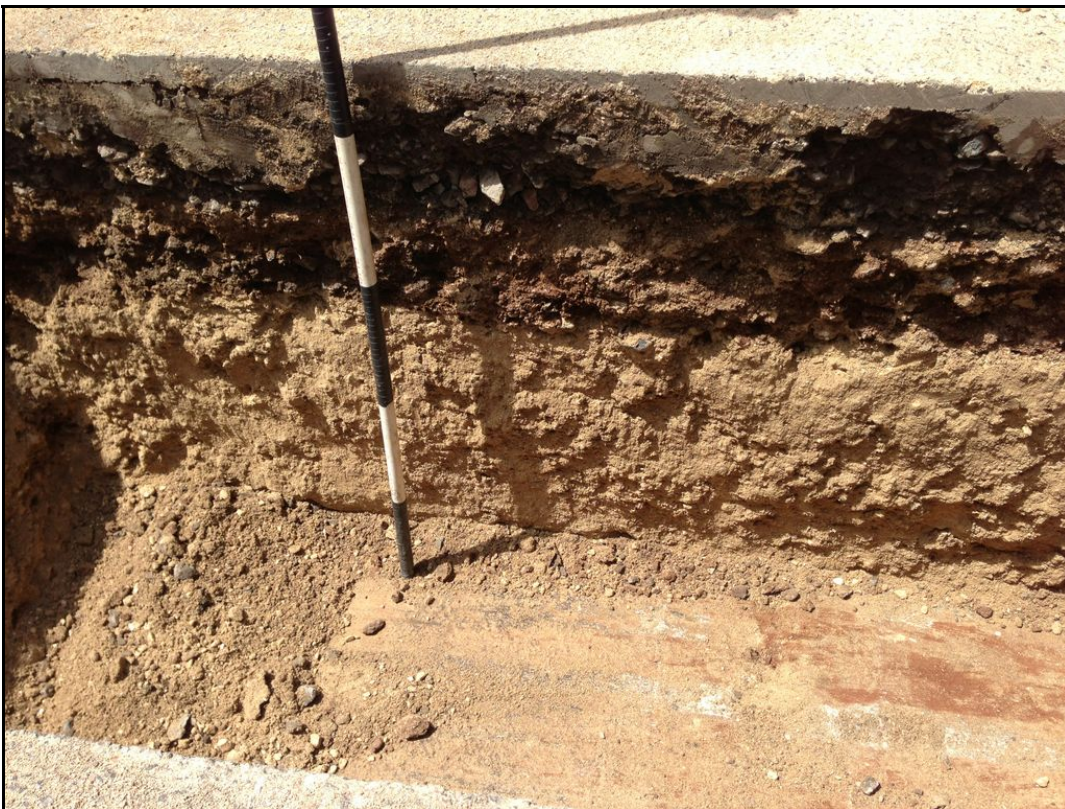
Stratigraphic Summary: The stratigraphy consisted of fill overlying a concrete slab (Figure 186 and Figure 187). Observed strata were asphalt (Stratum Ia), basalt base course (Stratum Ib), extremely gravelly sandy loam fill (Stratum Ic), and crushed coral fill (Stratum Id) overlying a buried concrete slab (Stratum II). The stratigraphy of T-026 conformed to the USDA soil survey designation of Fill land (FL).

Figure 186. Photograph of Airport Section 3, T-026, general view of profile, view to west

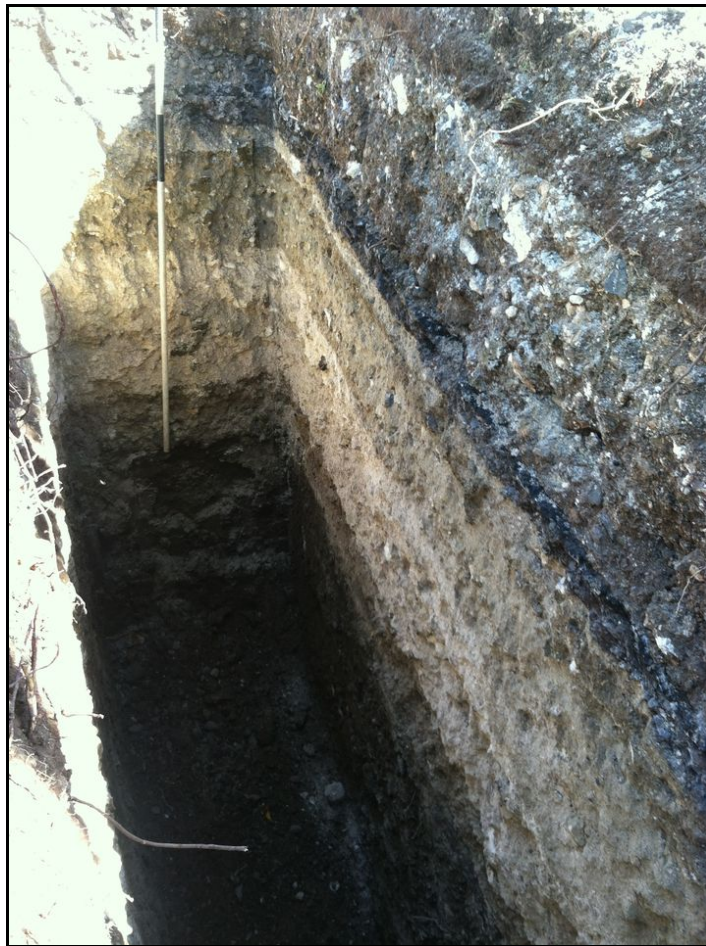
Stratigraphic Summary: The stratigraphy consisted fill strata over natural sediment (Figure 189 and Figure 190). Observed strata were very gravelly clay loam topsoil (Stratum Ia), gravelly sandy clay loam (Stratum Ib), a buried asphalt layer (Stratum IIa), basalt gravel base course (Stratum IIb), crushed coral fill (Stratum IIc), and very gravelly sand fill (Strata IId to IIe), overlying natural alluvial sediment of silty clay loam (Stratum III) to the coral shelf. The buried asphalt pavement (Stratum IIa) does not correspond to the location of any paved roads on the historic maps examined and likely represents infrastructure less than 50 years of age. The

Figure 189. Photograph of Airport Section 3, T-027, general view of profile, view to southeast

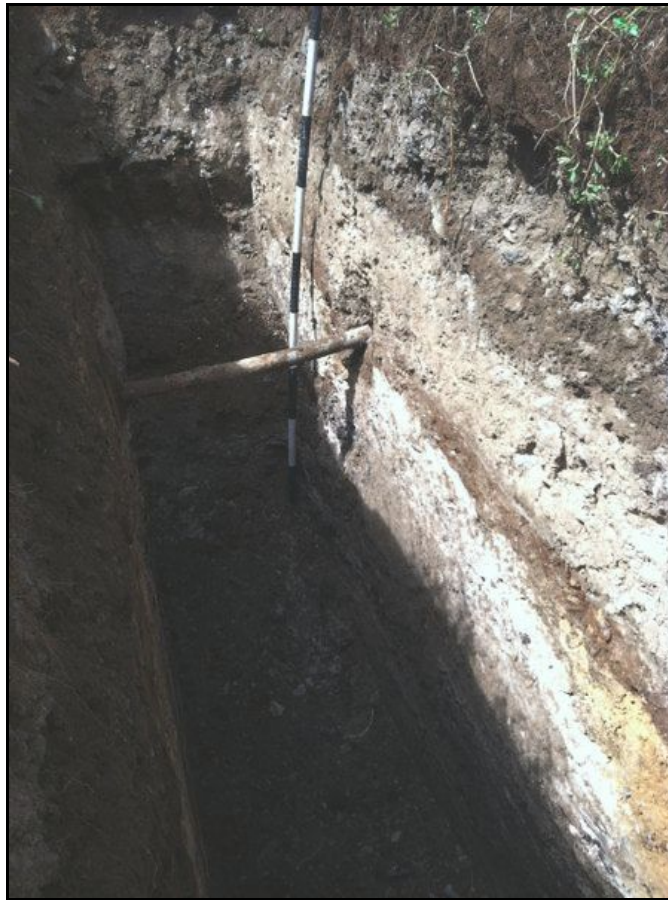
Figure 192. Photograph of Airport Section 3, T-028, general view of profile, view to northwest

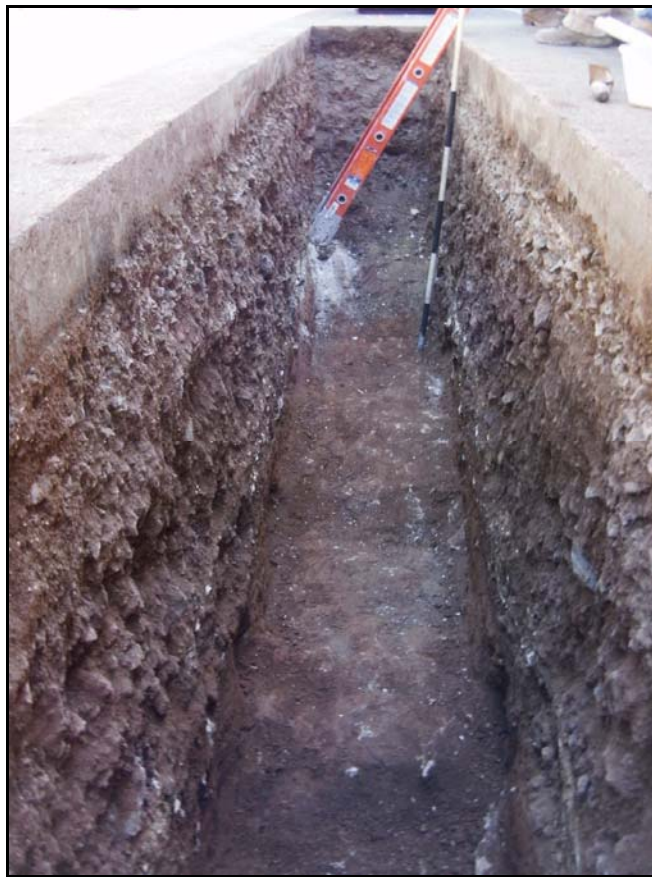
Stratigraphic Summary: The stratigraphy of T-029 consisted of fill strata over natural sediment (Figure 195 and Figure 196). Observed strata were asphalt (Stratum Ia) and associated base course fill (Stratum Ib) overlying natural silty clay loam (Stratum II) above the coral shelf. Stratum II was previously disturbed or reworked natural sediment. The stratigraphy above Stratum II conformed to the USDA soil survey designation of Fill land (FL).

Figure 195. Photograph of Airport Section 3, T-029, general view of profile, view to west

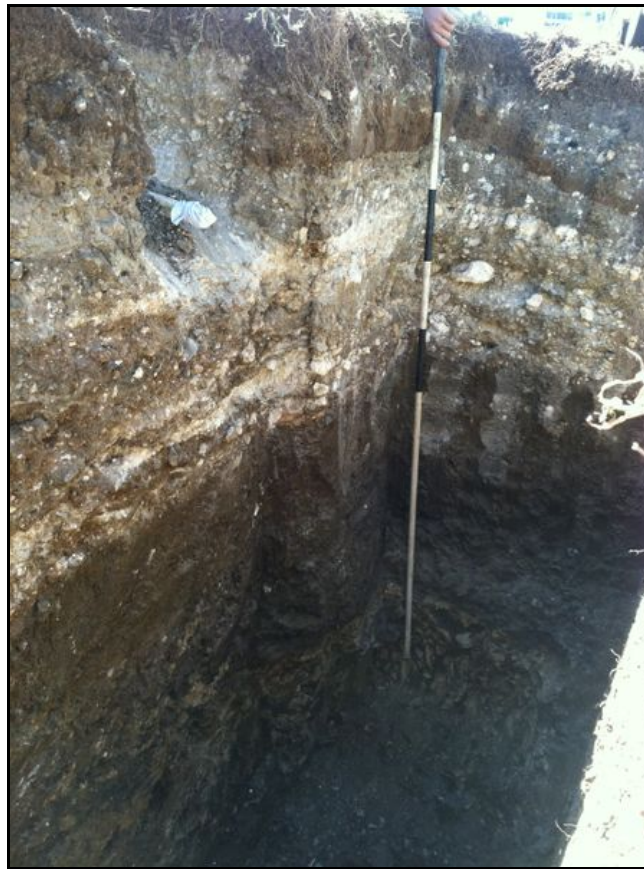
Stratigraphic Summary: The stratigraphy consisted of fill strata to the base of excavation (Figure 198 and Figure 199). Observed strata included very gravelly silty loam fill (Stratum Ia), very gravelly cobbly sandy loam (Stratum Ib), gravelly sandy loam fill (Stratum Ic), very cobbly loam fill (Stratum Id), and gravelly loam fill (Stratum Ie) to the base of excavation. Stratum Id contained angular basalt cobbles and cobble-sized asphalt inclusions. Also present was a utility pit intrusive into the two upper-most fill deposits (Stratum Ia and Ib) for a PVC pipe toward the western end of T-030. The stratigraphy conformed to the USDA soil survey designation of Fill land (FL).

Figure 198. Photograph of Airport Section 3, T-030, general view of profile, view to southwest

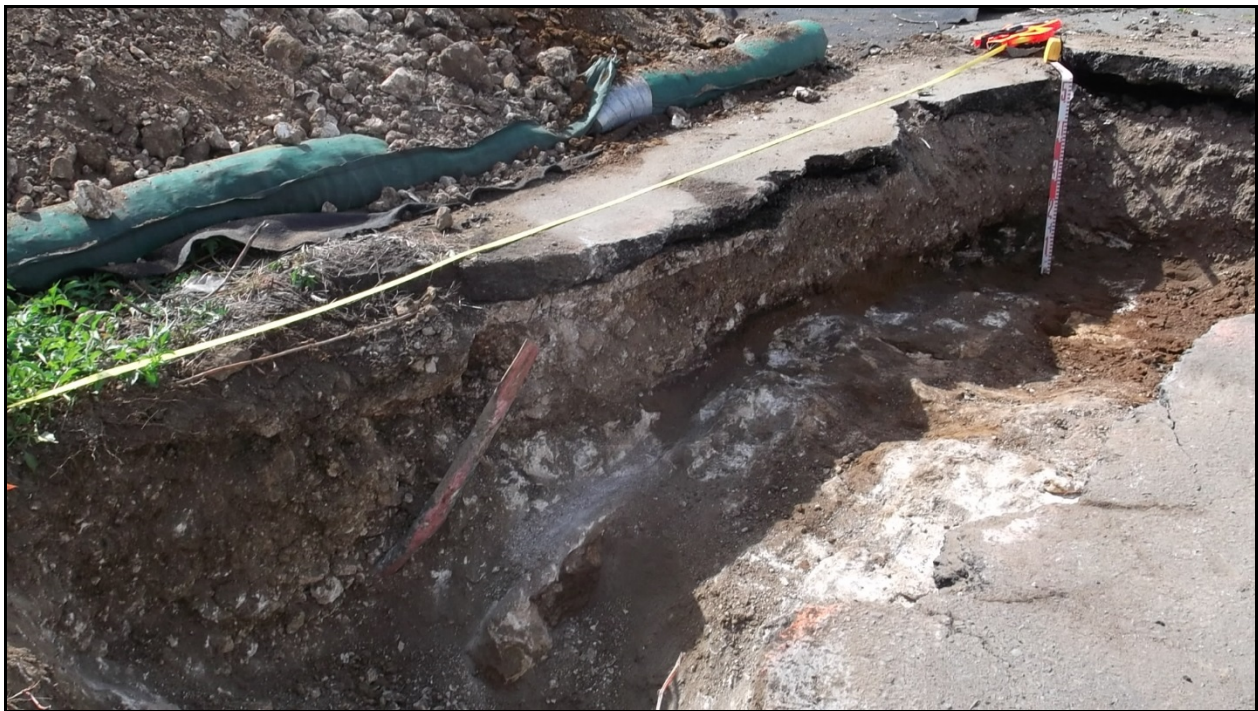
Stratigraphic Summary: The stratigraphy consisted of fill strata over natural sediment (Figure 201 and Figure 202). Observed strata included asphalt (Stratum Ia) and associated base course (Stratum Ib) continuous over the excavation area. A utility trench around the metal pipe truncated through the strata in the northern end of T-031, and the fill consisted of crushed coral (Stratum Ic) and very gravelly loam (Stratum Id). The stratigraphy in the remainder of the excavation area consisted of extremely gravelly loam fill (Stratum Ie), and loam fill (Stratum If) overlying natural loam (Stratum II) and the coral shelf. Stratum II generally conformed to the USDA soil survey designation for this location of Keaau stony clay (KmaB). The upper boundary of Stratum II exhibited evidence of previous disturbance.

Figure 201. Photograph of Airport Section 3, T-031, general view of profile, view to southeast

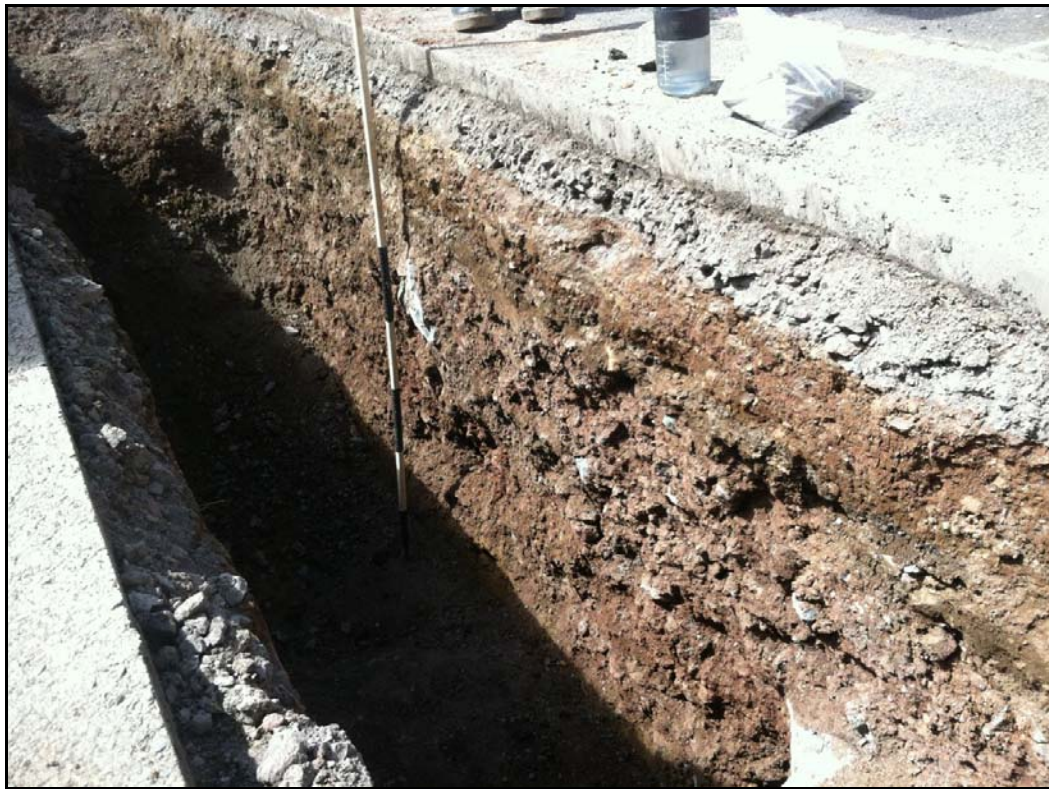
Stratigraphic Summary: The stratigraphy at T-033 consisted of fill overlying natural sediment (Figure 208 and Figure 209). Observed strata were asphalt (Stratum Ia), gravel base course (Stratum Ib), very gravelly sandy loam fill (Stratum Ic), gravelly sandy loam fill (Stratum Id), very gravelly to stony loam fill (Stratum Ie), and natural silty clay loam (Stratum II) above the coral shelf (Stratum III). Stratum II conformed with the USDA soil survey designation of Ewa clay loam (EmA)

Figure 208. Photograph of Airport Section 3, T-033, general view of profile, view to north

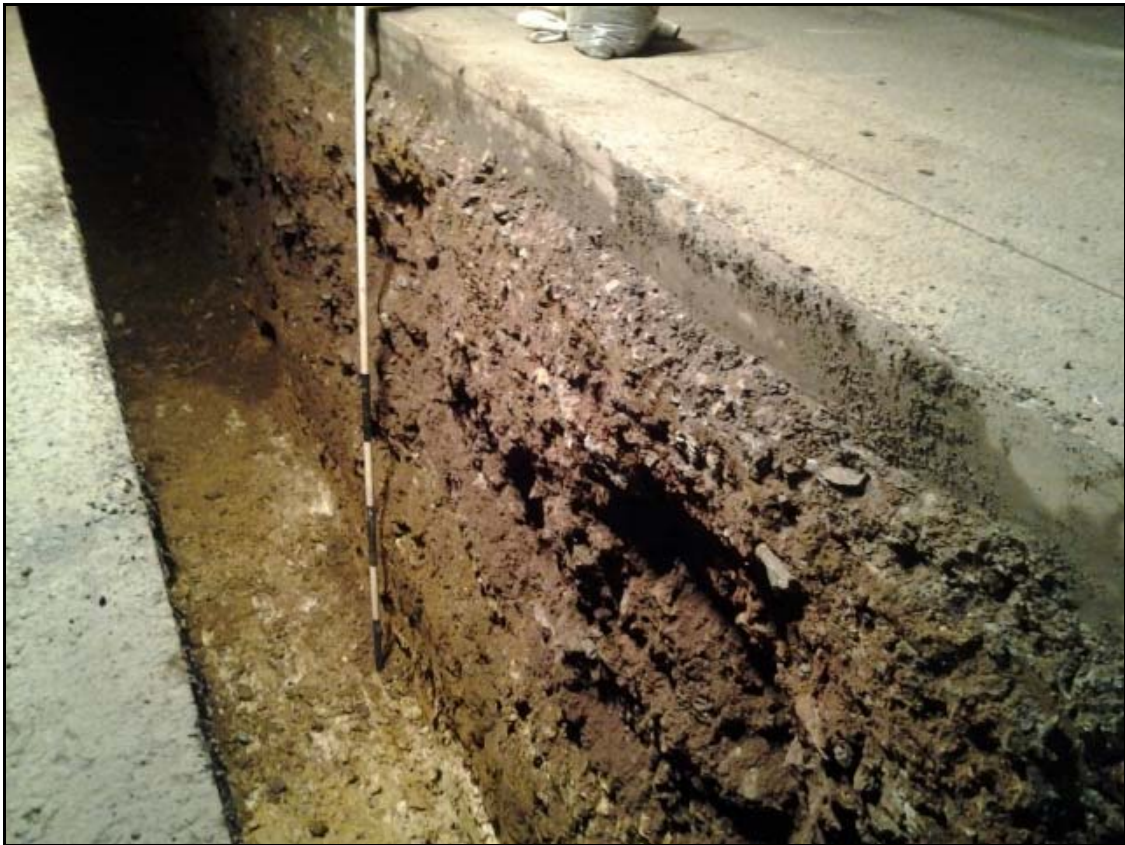
Stratigraphic Summary: The stratigraphy at T-035 consisted of fill material overlying natural sediment (Figure 214 and Figure 215). Observed strata were asphalt (Stratum Ia), associated base course (Stratum Ib), very gravelly silty clay fill (Stratum Ic), very gravelly silty clay fill (Stratum Id), and very cobbly silty clay fill (Stratum Ie) overlying natural silty clay (Stratum II) and decomposing coral shelf (Stratum III) above the coral shelf. Stratum II conformed to the USDA soil survey designation of Ewa silty clay loam (EmA).

Figure 214. Photograph of Airport Section 3, T-035, general view of profile, view to southeast

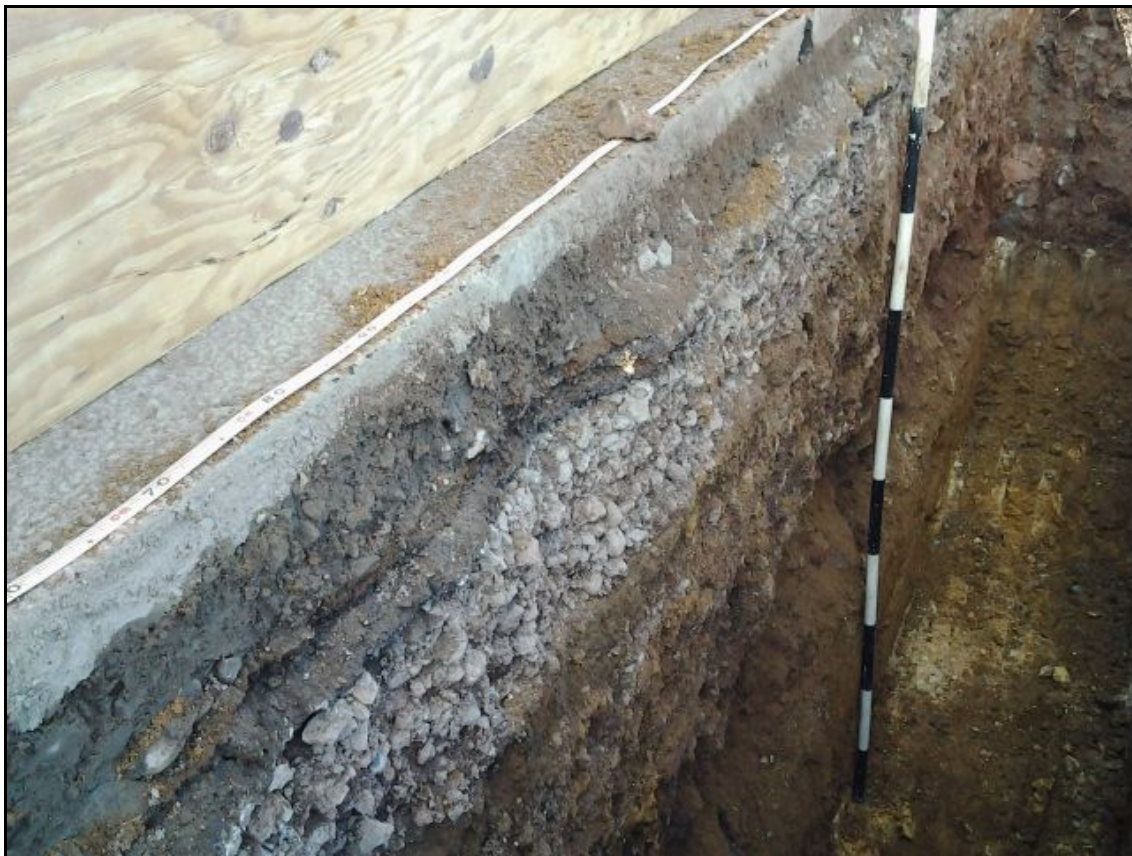
Stratigraphic Summary: The stratigraphy of T-036 consisted of fill strata over natural sediment (Figure 217 and Figure 218). Observed strata were asphalt (Stratum Ia) and associated base course (Stratum Ib), a buried asphalt pavement (Stratum Ic), associated base course (Stratum Id), clay fill (Stratum Ie), and very gravelly to cobbly loam (Stratum If), overlying natural clay (Stratum II) to the coral shelf (Stratum III). The stratigraphy generally conformed to the USDA soil survey designation of Ewa silty clay loam (EmA).

Figure 217. Photograph of Airport Section 3, T-036, general view of profile, view to southwest

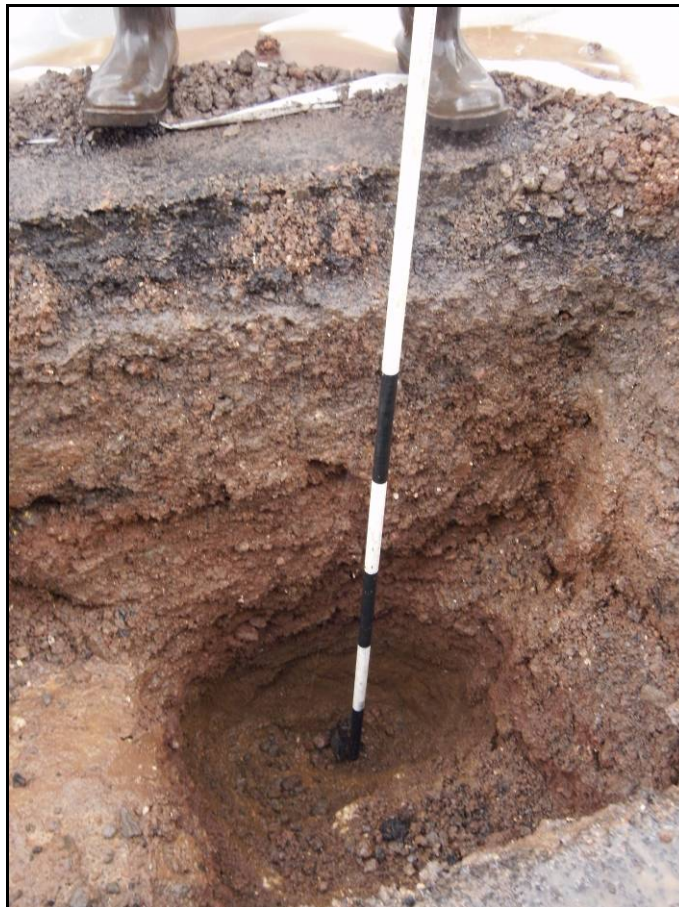
Stratigraphic Summary: The stratigraphy of T-037 consisted of fill strata over natural sediment (Figure 220 and Figure 221). Observed strata were asphalt (Stratum Ia), associated base course (Stratum Ib), and gravelly cobbly loam (Stratum Ic), overlying natural sandy clay loam (Stratum II) above the coral shelf. The stratigraphy generally conformed to the USDA soil survey designation of Ewa silty clay loam (EmA).

Figure 220. Photograph of Airport Section 3, T-037, general view of profile, view to southeast

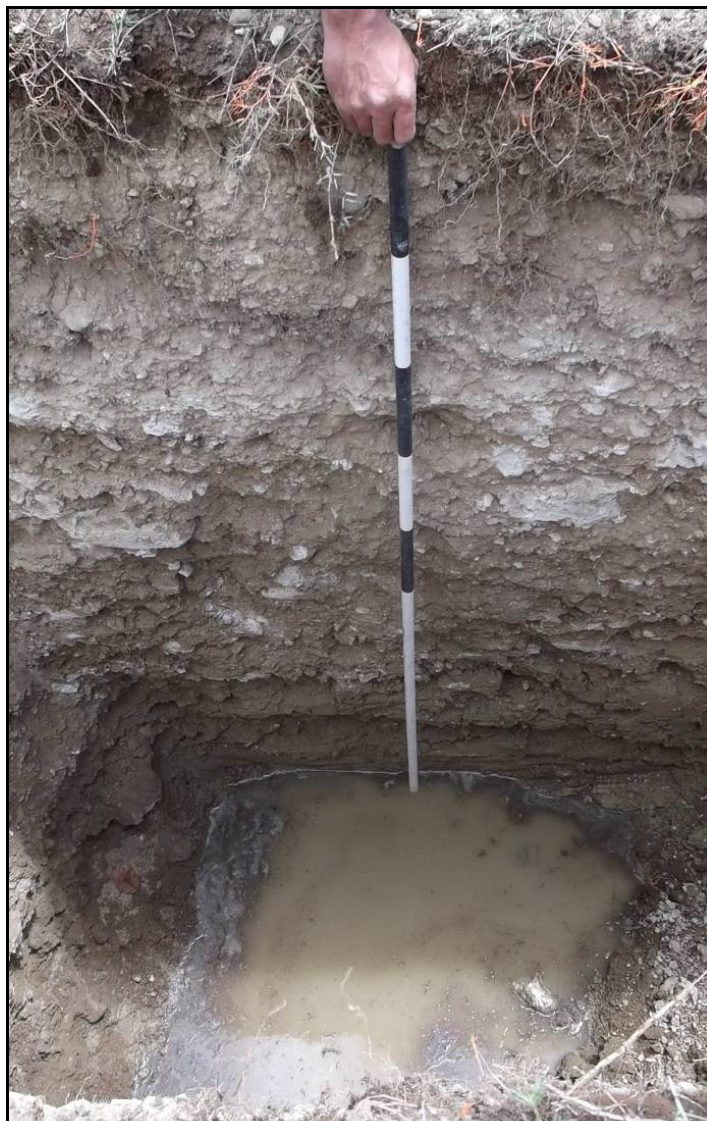
Stratigraphic Summary: The stratigraphy of T-038 consisted of fill strata over natural sediment (Figure 223 and Figure 224). Observed strata were topsoil (Stratum Ia), crushed coral fill (Stratum Ib), and hydraulic fill (Stratum Ic) overlying natural sandy clay (Stratum II). The stratigraphy generally conformed to the USDA soil survey designation of Fill land (FL).

Figure 223. Photograph of Airport Section 3, T-038, general view of profile, view to southeast

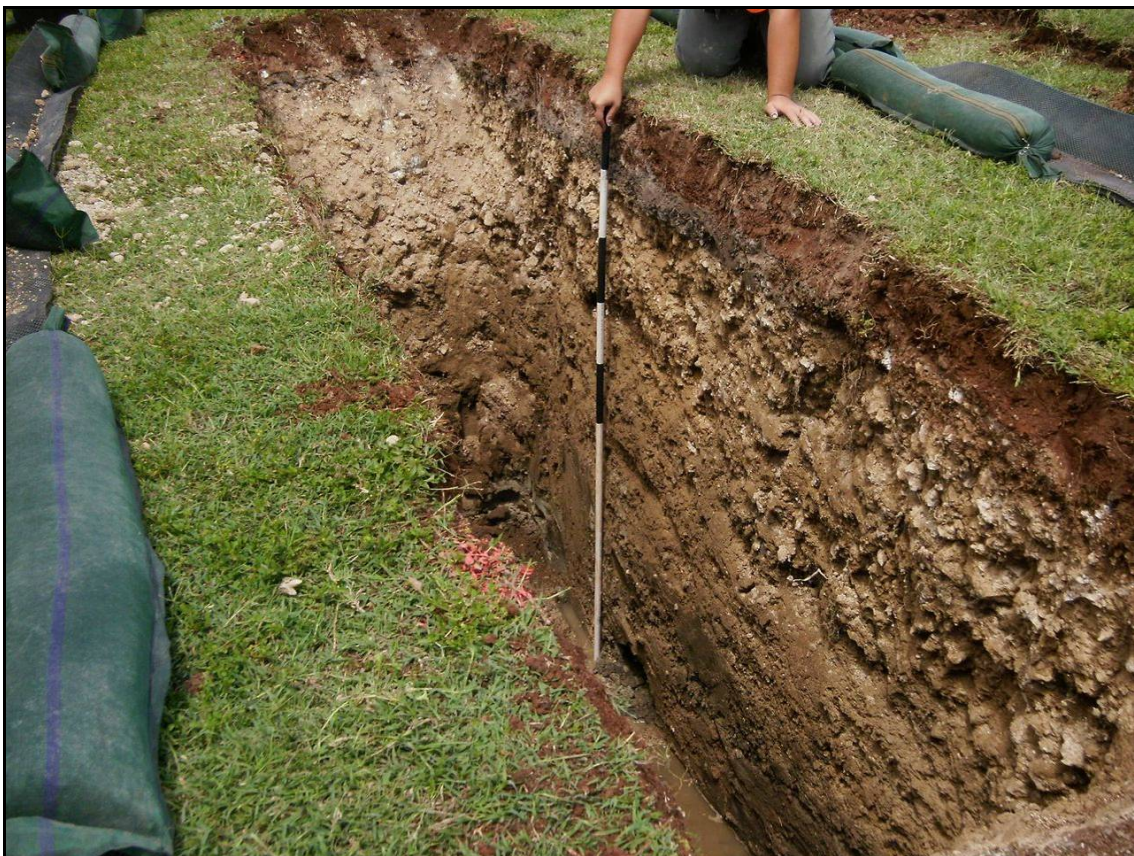
Stratigraphic Summary: The stratigraphy of T-039 consisted of fill strata over natural sediment (Figure 226 and Figure 227). Observed strata were topsoil (Stratum Ia), silty clay loam (Stratum Ib), and crushed coral fill (Stratum Ic) overlying natural silty clay (Stratum IIa and IIb). The stratigraphy generally conformed to the USDA soil survey designation of Fill land (FL).

Figure 226. Photograph of Airport Section 3, T-039, general view of profile, view to northwest

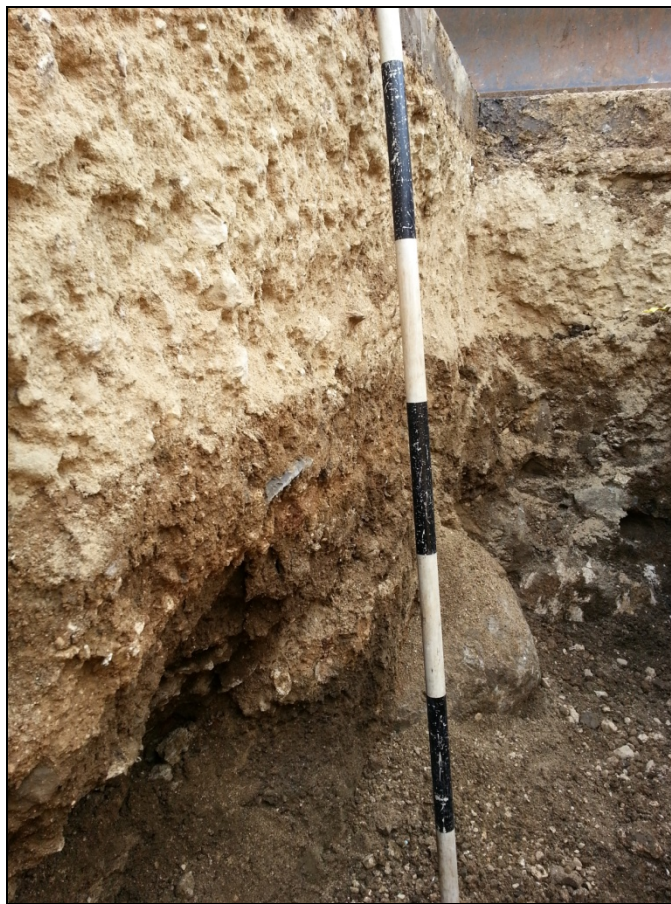
Stratigraphic Summary: The stratigraphy of T-041 consisted of fill strata over natural sediment and basalt bedrock (Figure 232 and Figure 233). Observed strata were asphalt (Stratum Ia), associated base course (Stratum Ib), extremely gravelly sand fill (Stratum Ic), gravelly sandy loam fill (Stratum Id), and very gravelly silty sand fill (Stratum Ie) overlying natural clay (Stratum II) and basalt bedrock (Stratum III). The stratigraphy generally conformed to the USDA soil survey designation of Fill land (FL) above Stratum II.

Figure 232. Photograph of Airport Section 3, T-041 general view of profile, view to northwest

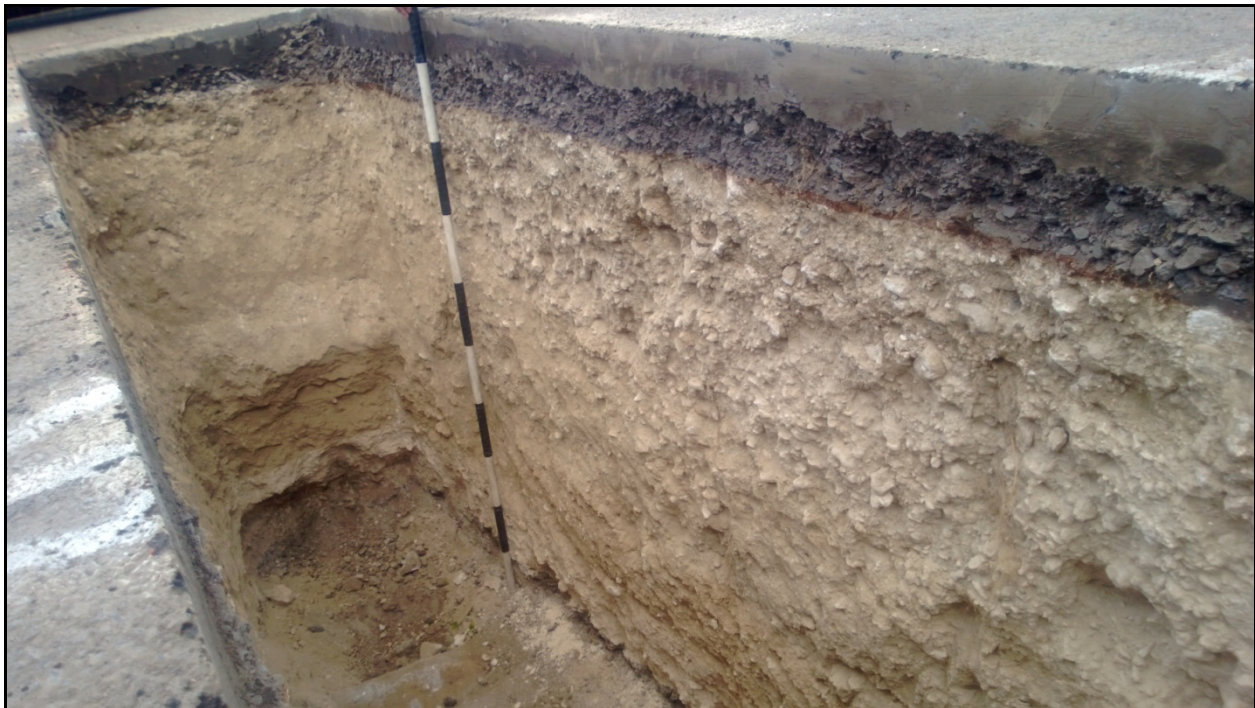
Stratigraphic Summary: The stratigraphy of T-042 consisted of fill strata over a concrete slab (Figure 235 to Figure 236). Observed strata were asphalt (Stratum Ia), associated basalt gravel base course (Stratum Ib), crushed coral fill (Stratum Ic), and very gravelly cobbly loamy sand fill (Stratum Id). A concrete slab, designated as SIHP # 50-80-13-7421 Feature 2, was encountered at the base of Stratum Id. The stratigraphy above Stratum Id conformed to the USDA soil survey designation of Fill land (FL).

Figure 235. Photograph of Airport Section 3, T-042, general view of profile, view to northeast

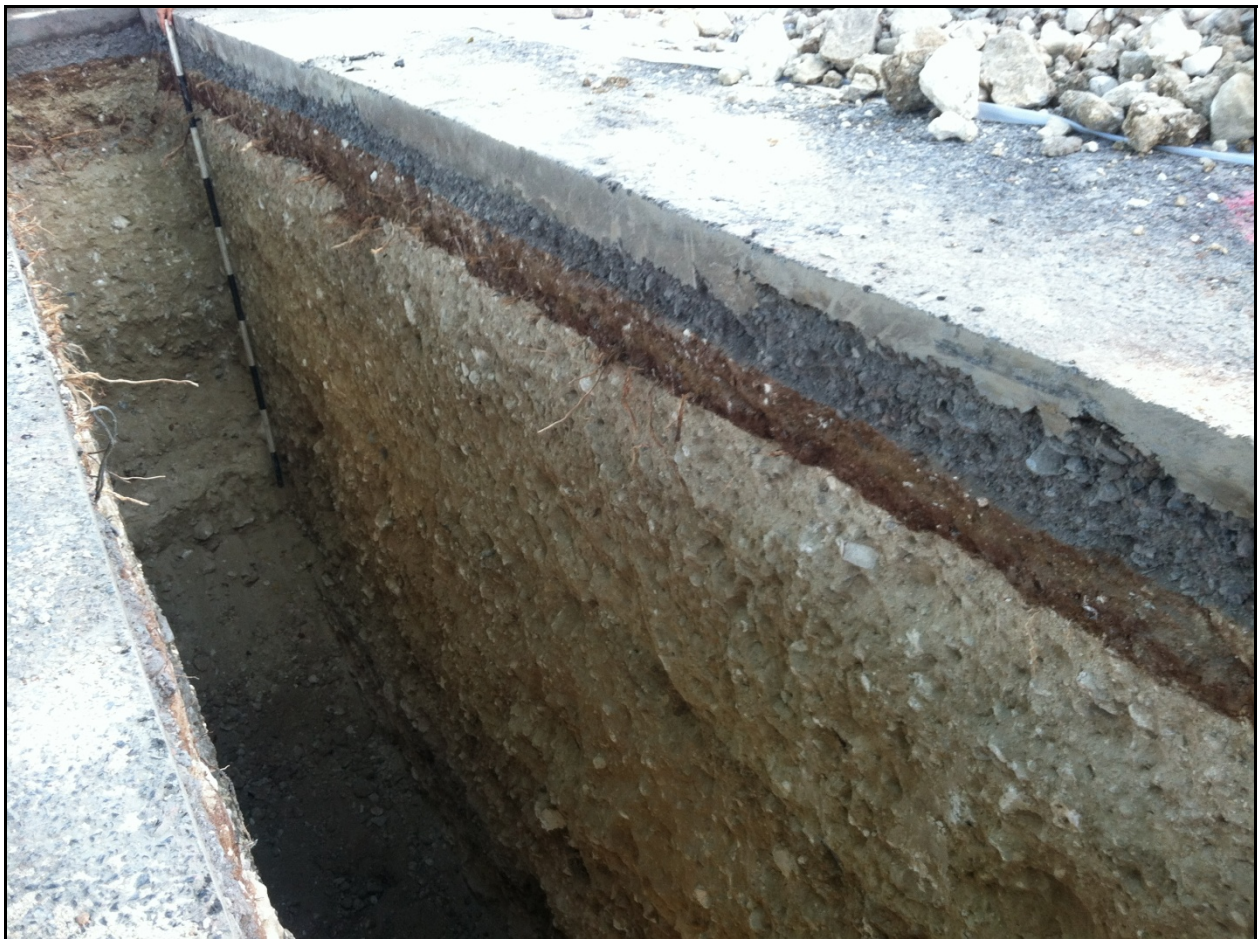
Stratigraphic Summary: The stratigraphy of T-043 (Figure 238 and Figure 239) consisted of fill strata to the base of excavation. Observed strata were asphalt (Stratum Ia), associated base course (Stratum Ib), very gravelly silt loam fill (Stratum Ic), very gravelly cobbly sandy loam fill (Stratum Id), loam fill (Stratum Ie), very gravelly sandy clay fill (Stratum If), and very gravelly sandy clay (Stratum Ig) to the base of excavation. The observed stratigraphy conformed to the USDA soil survey designation of Fill land (FL).

Figure 238. Photograph of Airport Section 3, T-043, general view of profile, view to southwest

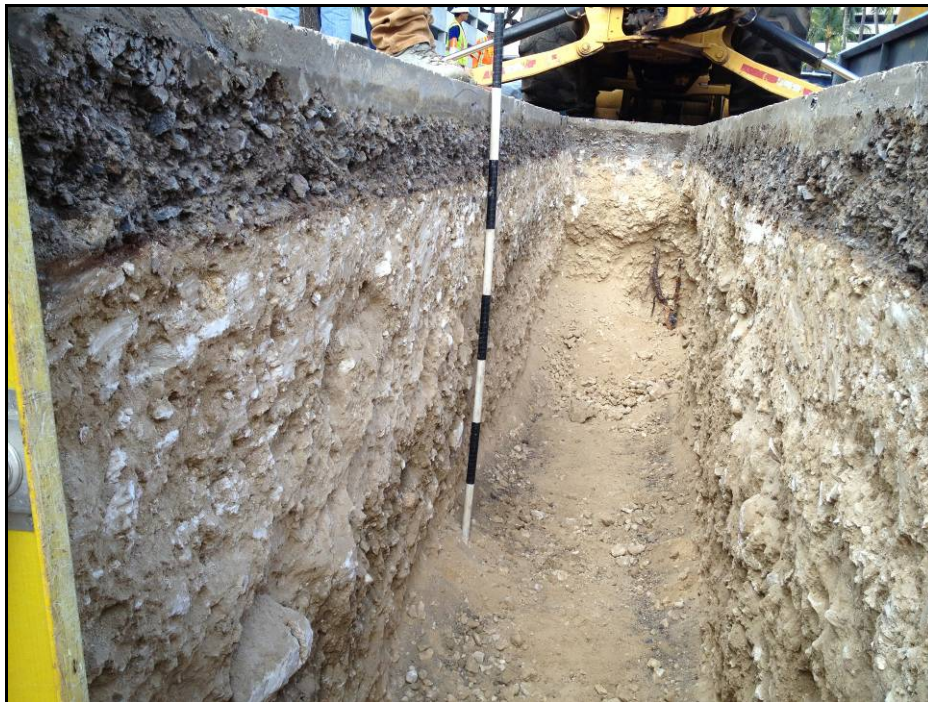
Stratigraphic Summary: The stratigraphy of T-044 consisted fill strata over the decomposing coral shelf. (Figure 241 and Figure 242) Observed strata were asphalt (Stratum Ia), associated base course (Stratum Ib), and crushed coral fill (Strata Ic and Id) overlying decomposing coral bedrock (Stratum II) and hard coral bedrock. The stratigraphy observed above the decomposing coral bedrock conformed to the USDA soil survey designation of Fill land (FL).

Figure 241. Photograph of Airport Section 3, T-044, general view of profile, view to southwest

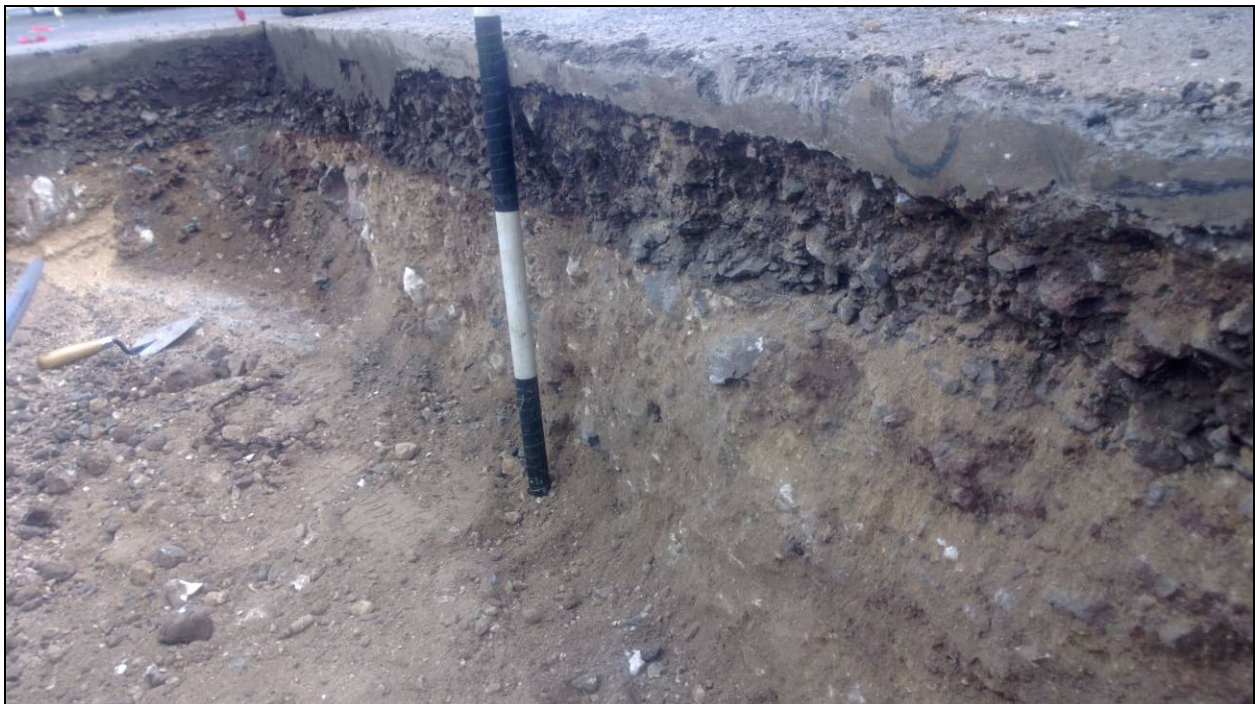
Stratigraphic Summary: The stratigraphy of T-045 consisted of fill strata to the base of excavation (Figure 244 and Figure 245). Observed strata were asphalt (Stratum Ia), basalt base course (Stratum Ib), and crushed coral fill (Stratum Ic). The observed stratigraphy in T-045 conformed to the USDA soil survey designation of Fill land (FL).

Figure 244. Photograph of Airport Section 3, T-045, general view of profile, view to northwest

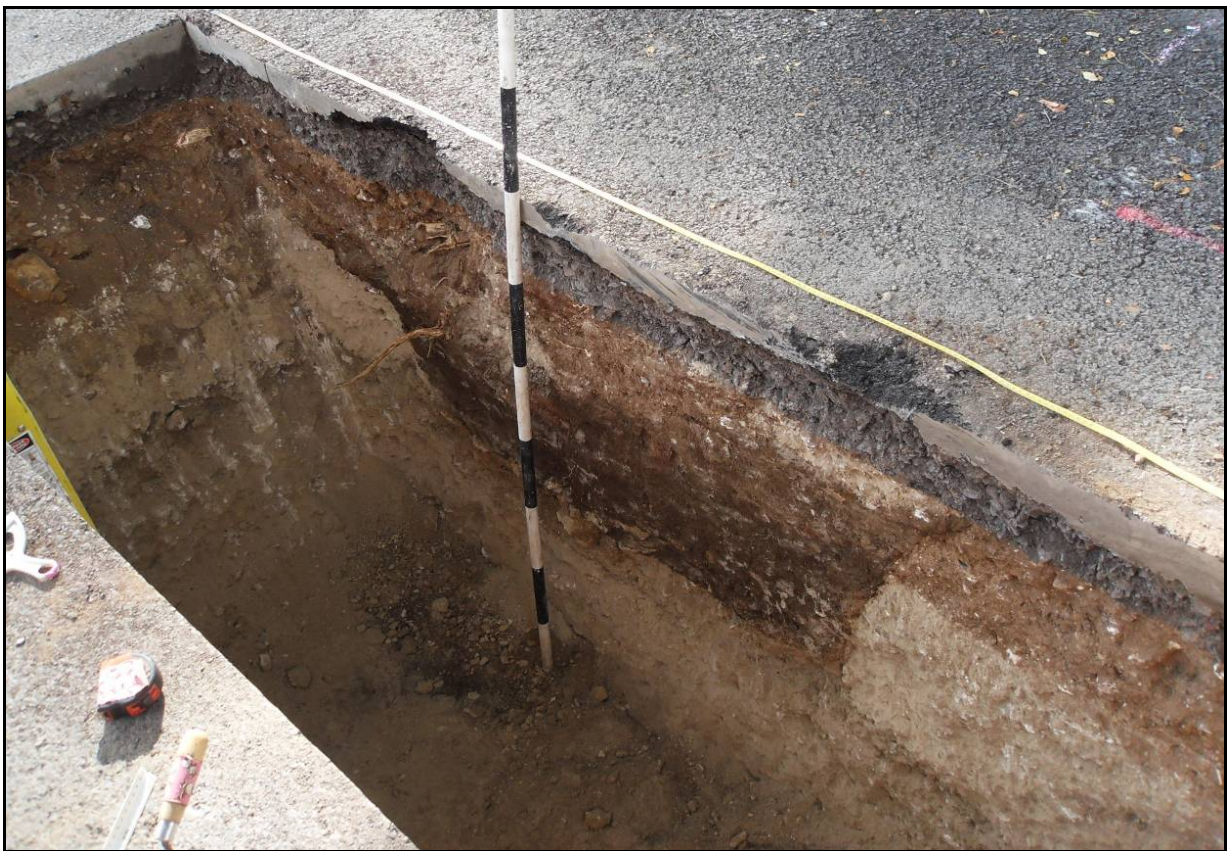
Stratigraphic Summary: The stratigraphy of T-046 consisted of fill strata to the base of excavation (Figure 247 and Figure 248). Observed strata were asphalt (Stratum Ia), associated base course (Stratum Ib), possible landscaping fill (Stratum Ic), gravelly silty clay loam fill (Stratum Id), crushed coral fill (Stratum Ie and If), and gravelly sandy clay fill (Stratum Ig), overlying a buried concrete slab (Stratum IIa/SIHP # 50-80-13-7421 Feature 2), buried asphalt pavement (Stratum IIb/SIHP # -7421 Feature 2), associated base course (Stratum IIc/SIHP #

Figure 247. Photograph of Airport Section 3, T-046, general view of profile, view to southeast

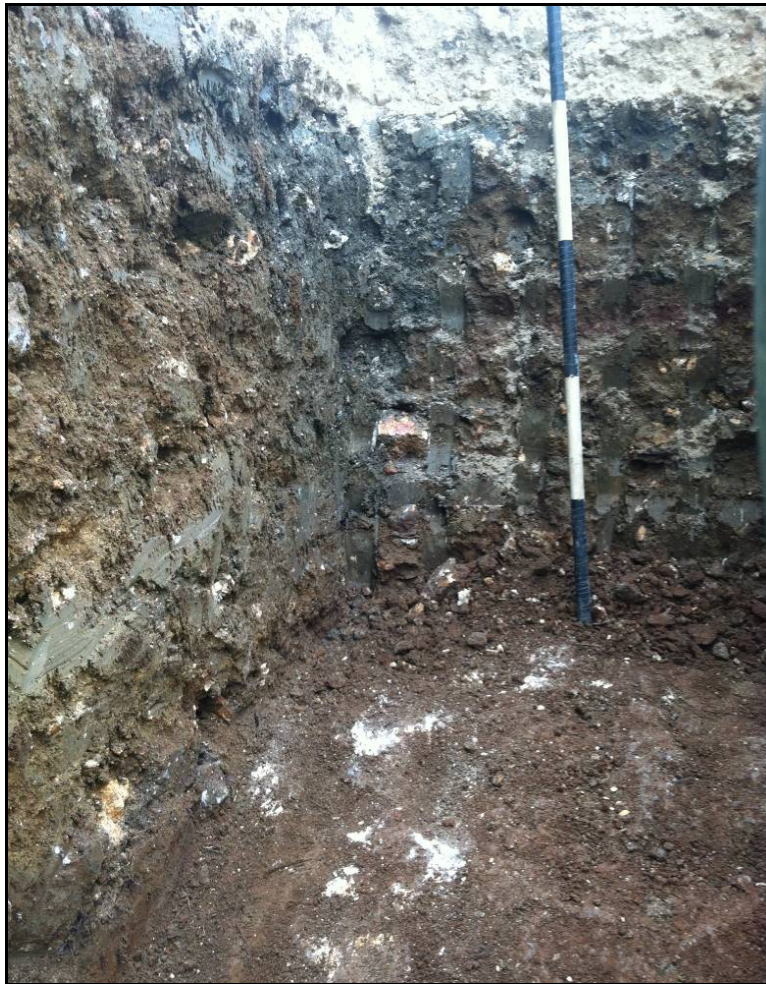
Stratigraphic Summary: The stratigraphy of T-047 consisted of fill strata overlying natural sediment (Figure 250 and Figure 251). Observed strata were asphalt (Stratum Ia), associated base course (Stratum Ib), very gravelly sandy loam fill (Stratum Ic), and very gravelly loam fill (Stratum Id) overlying natural silty clay loam (Stratum II) above the coral shelf. The observed stratigraphy above Stratum II generally conformed to the USDA soil survey designation of Fill land (FL).

Figure 250. Photograph of Airport Section 3, T-047, general view of profile, view to southeast
